SEATTLE CITY LIGHT WORK ORDER #89-6 Property Management
1989 QUARTERLY MONITORING OF THE GEORGETOWN FLUME

RAVEN SERVICES CORPORATION
2200 SIXTH AVENUE, SUITE 519
SEATTLE, WASHINGTON 98121
(206) 443-1126; FAX (206) 443-1128

June 21, 1989

SEATTLE CITY LIGHT WORK ORDER #89-6
1989 QUARTERLY MONITORING OF THE GEORGETOWN FLUME

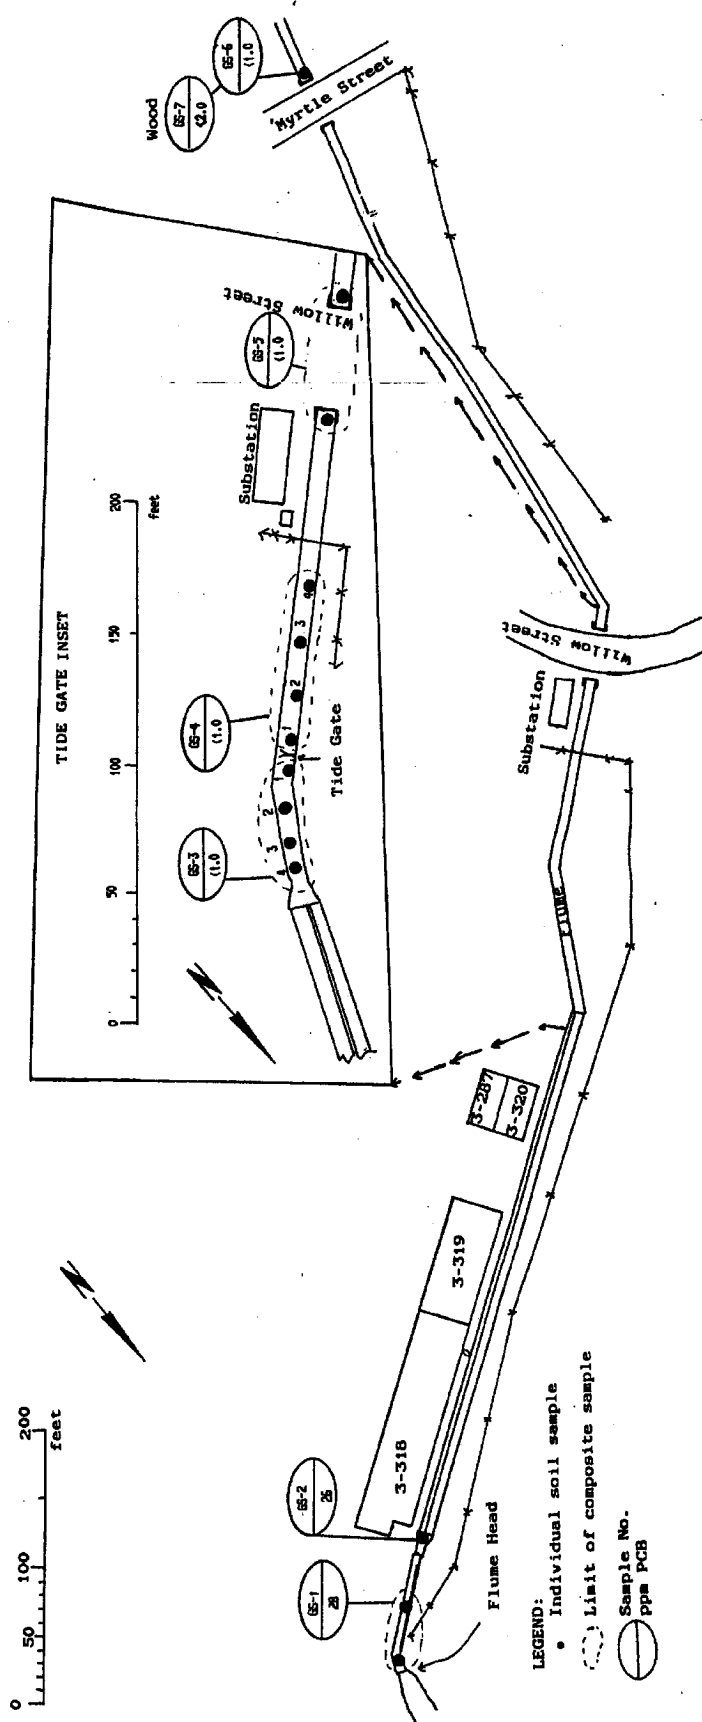
LOCATION OF SAMPLING POSITIONS, GEORGETOWN FLUME

Wood cores were specified for this project, however, since the wire mesh prevented the use of the corer upstream of Myrtle Street, a core was obtained there. Raven has since devised a corer that can sample any of the wood floor locations for future use. Sampling locations are shown in the Figure.

For the next monitoring task, we recommend that sampling at Myrtle Street be dropped, and that two wood cores are obtained between Willow Street and the double pipe mouth. The total number of samples remains at seven. Seattle City Light might consider pumping out the flume head in the near future.
